## West Manhood Drainage Improvement Group

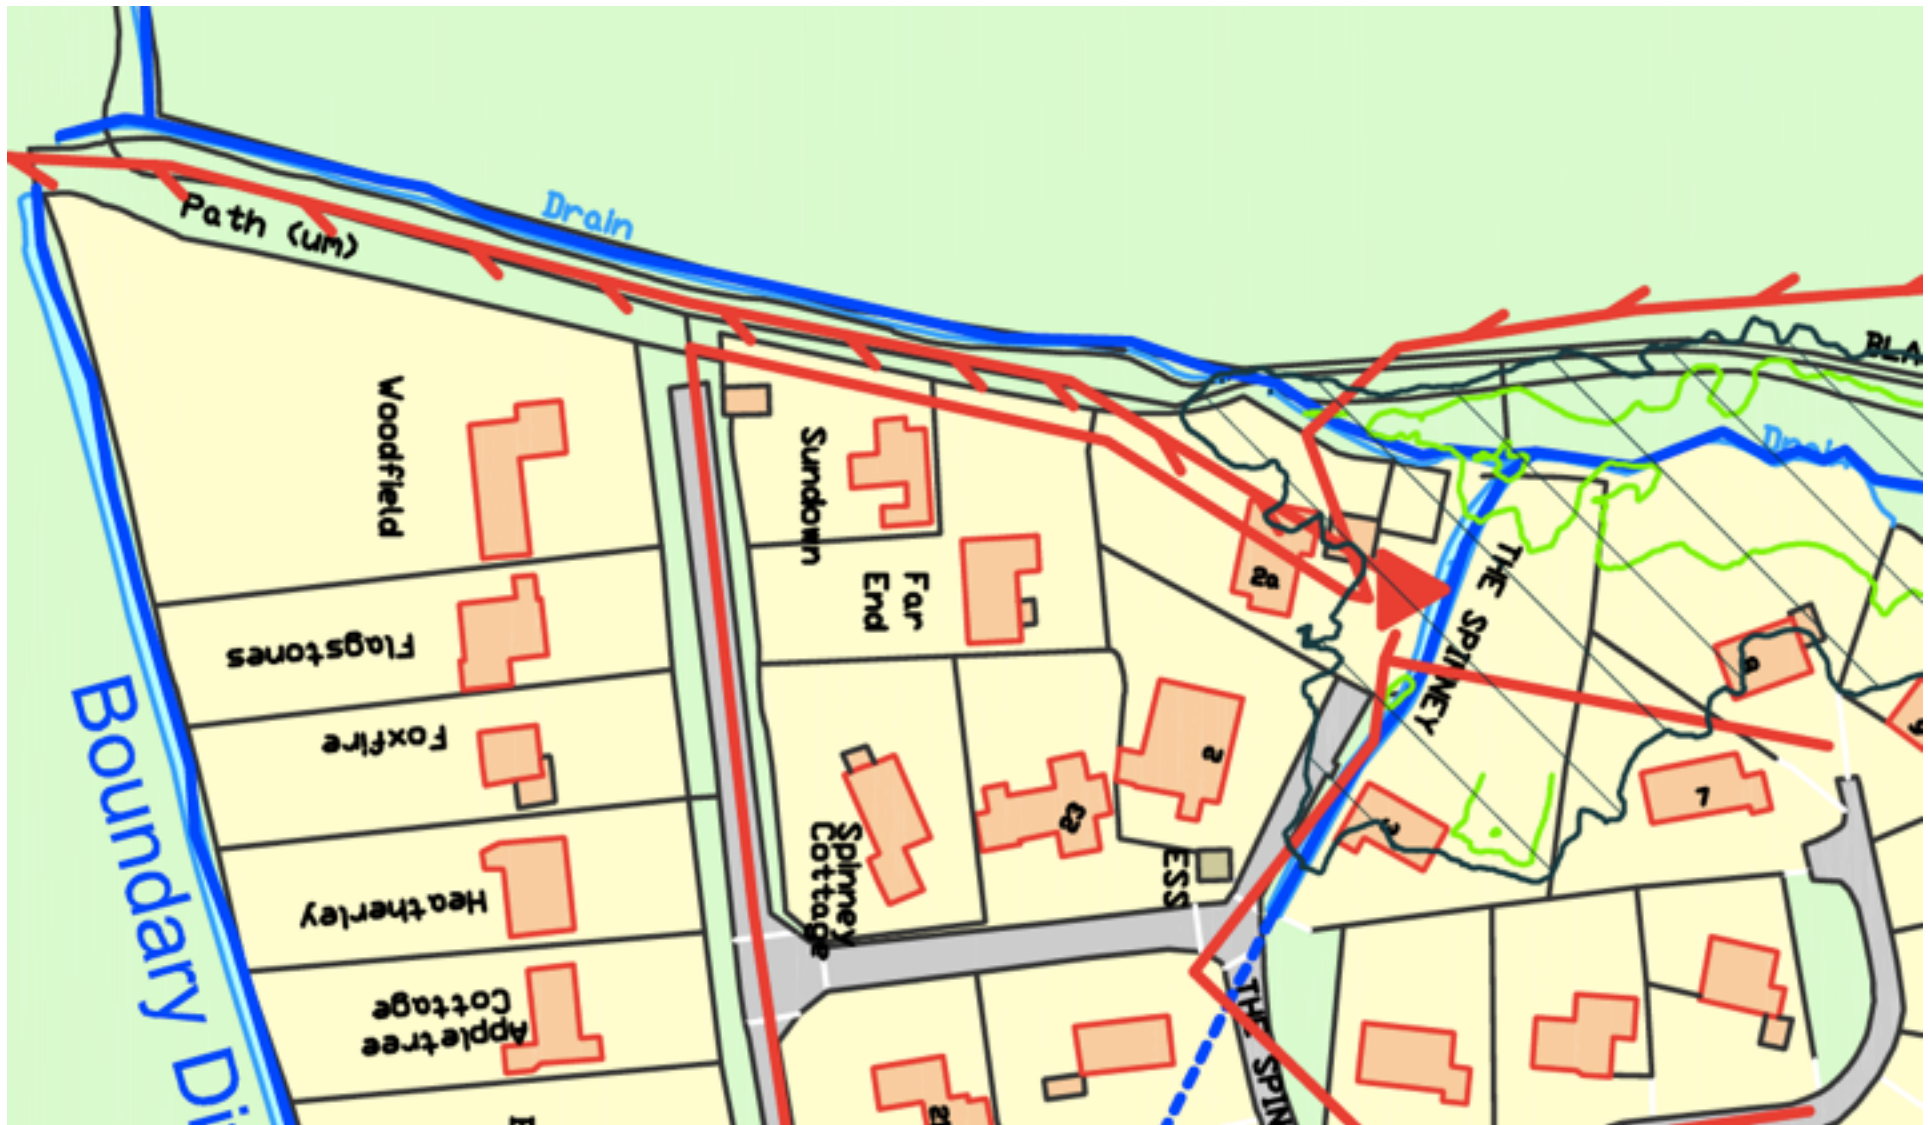
The drain along Blackhouse Lane is not flowing freely, holding back ground water in fields to the South and West. The farmers need to re open this so will need to remove recent tree growth between the footpath and the ditch.

The stream runs through a pipe under the footpath and then through the rear of gardens in the Spinney before entering the Pond.

These owners have in various ways tried to reclaim the Rife as garden by restricting the flow with a timber canal, woodchips, grass cuttings etc. This will result in flooding that could effect the foul system to the village as well as local rainwater flooding. This is a breach of Riparian responsibilities.

I have suggested that after September this would be good news but seek the PC resolve to proceed and try to keep a clear verge for future maintenance. Note that the pumped rising foul drain runs under this path.
